THE  
ONTARIO WATER RESOURCES  
COMMISSION

WATER POLLUTION SURVEY

SEPARATED TOWN OF INGERSOLL

JUNE 27 and 28, 1966

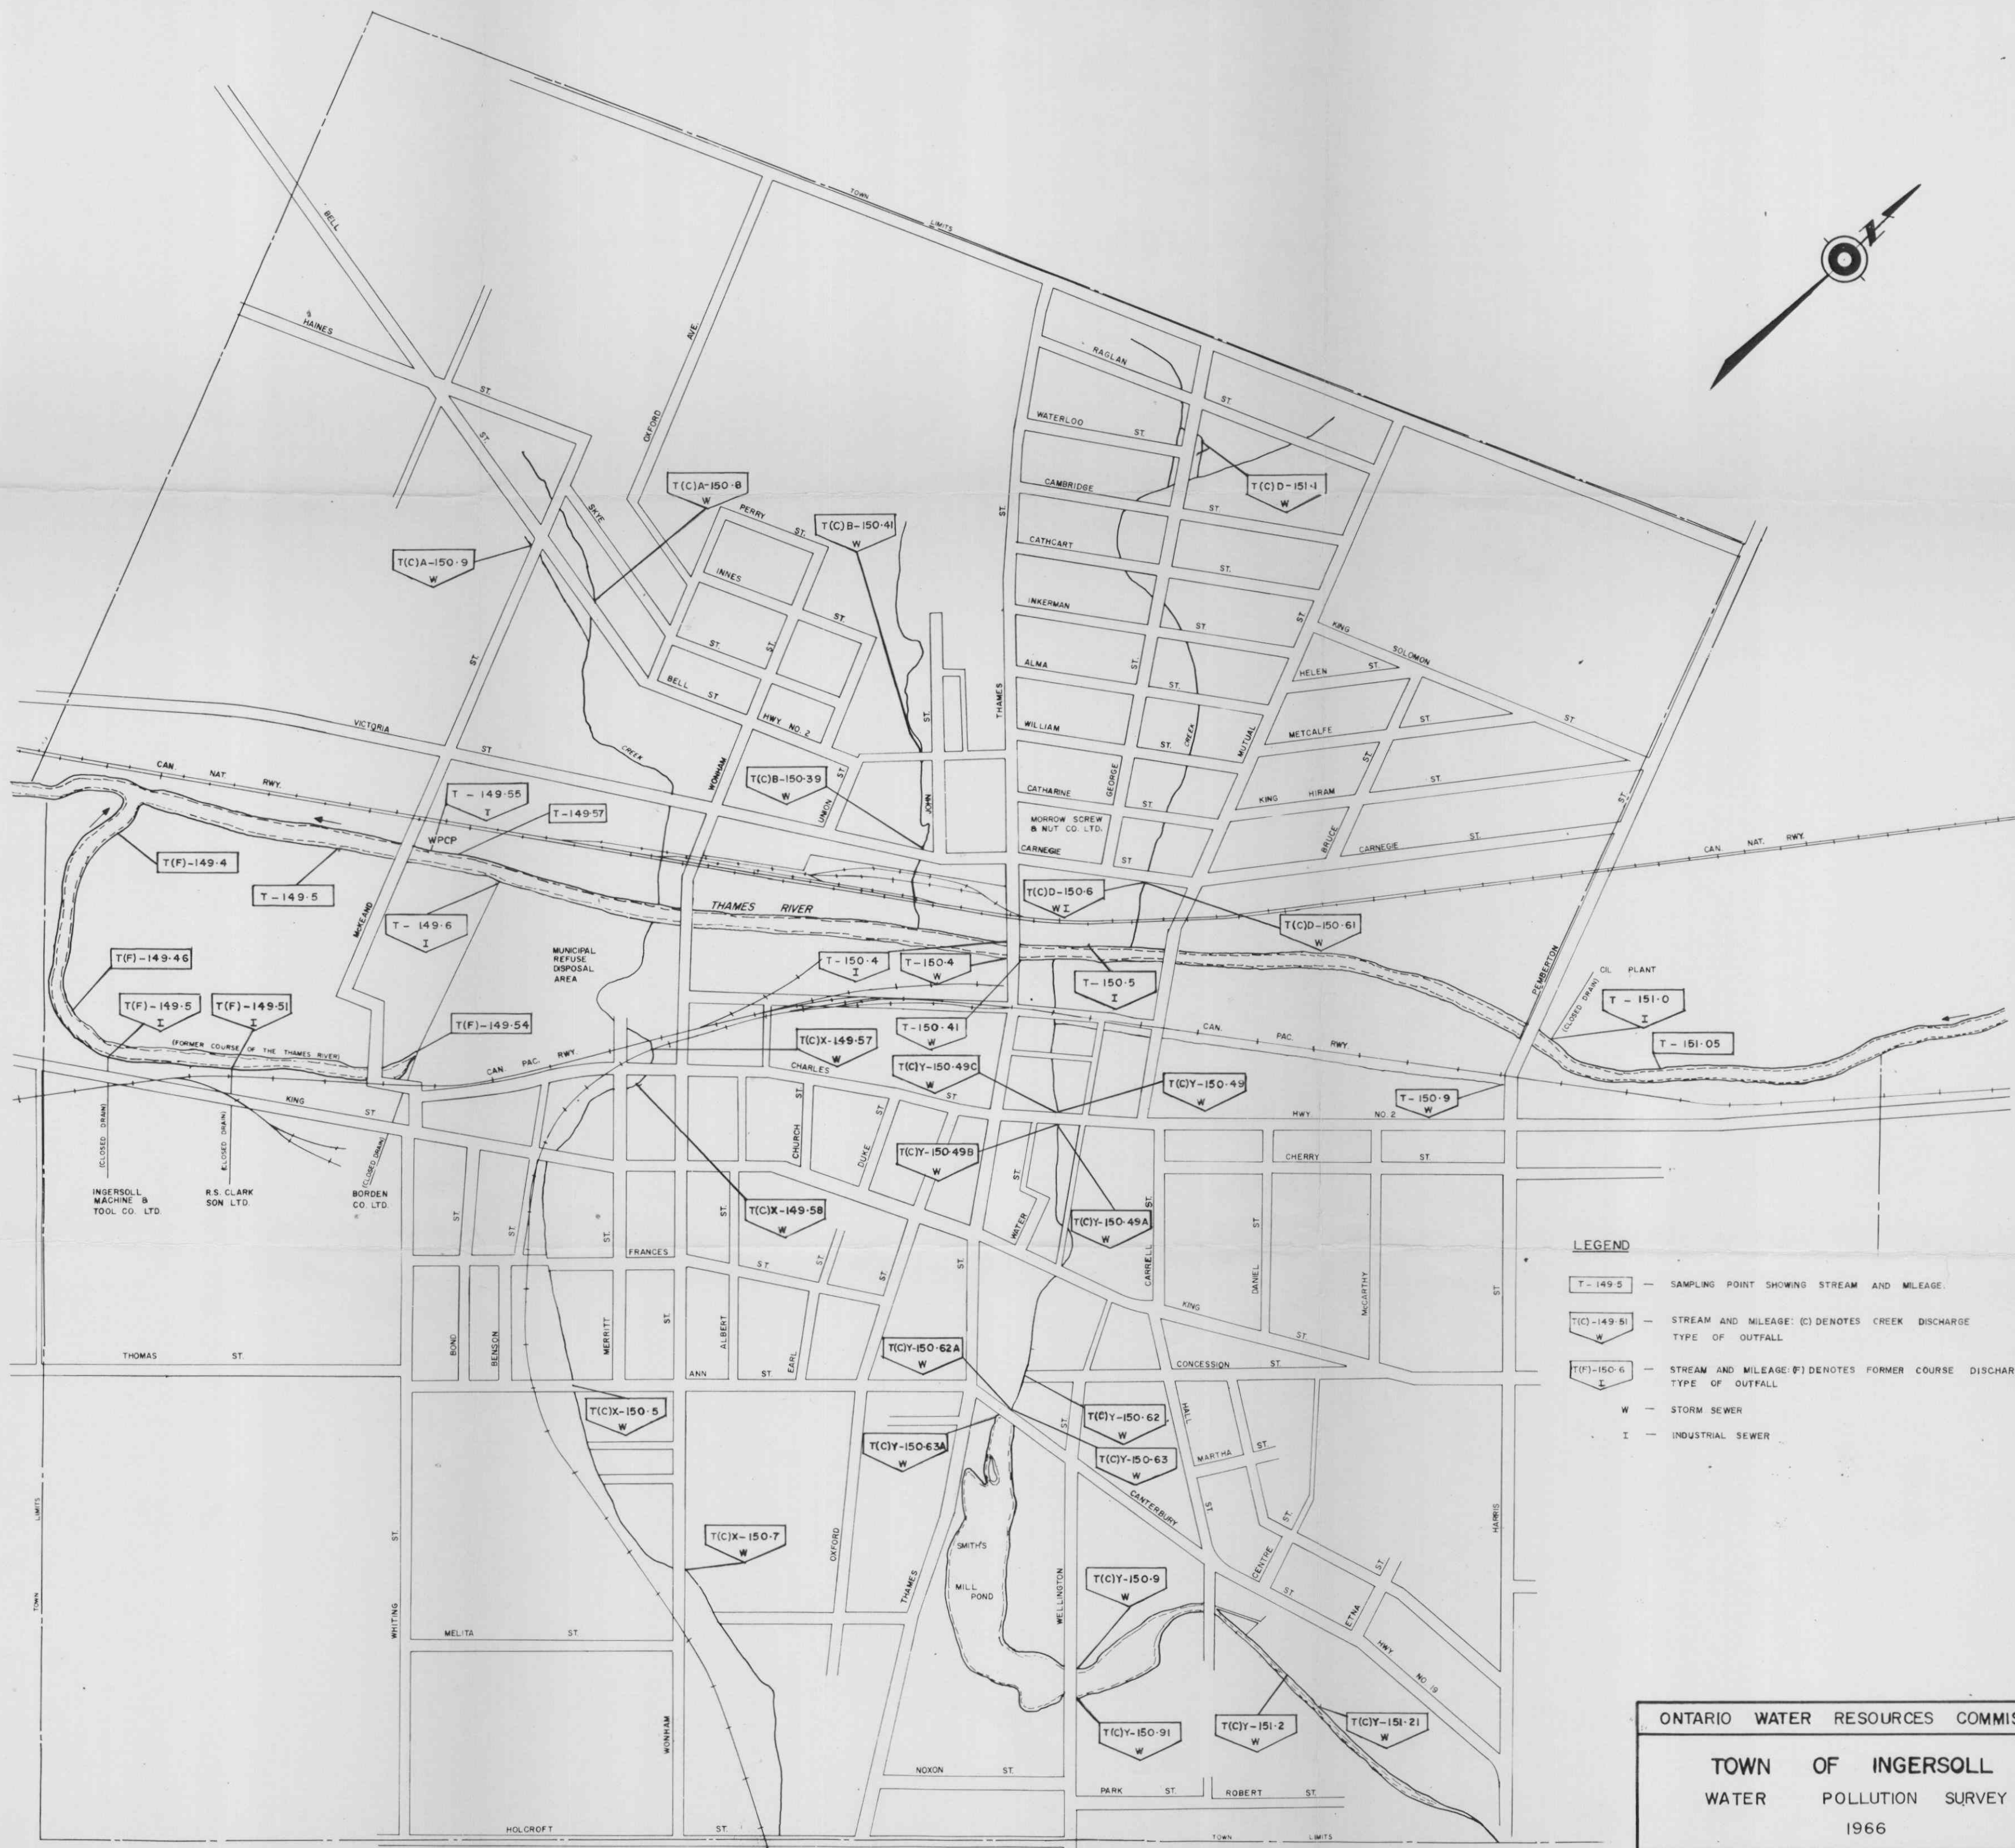
TOWN OF INGERSOLL  
WATER POLLUTION SURVEY  
1966

The laboratory results of the bacteriological examinations and the chemical analyses of the samples collected are listed in Table I. The location of the sampling points are indicated on the accompanying map.
